**FIELD OVERSIGHT SUMMARY REPORT
ACS NPL SITE
GRIFFITH, INDIANA**

November 8, 1999

BLACK & VEATCH
SPECIAL PROJECTS CORP.

USEPA/ARCS V
BVSPC Oversight Summary

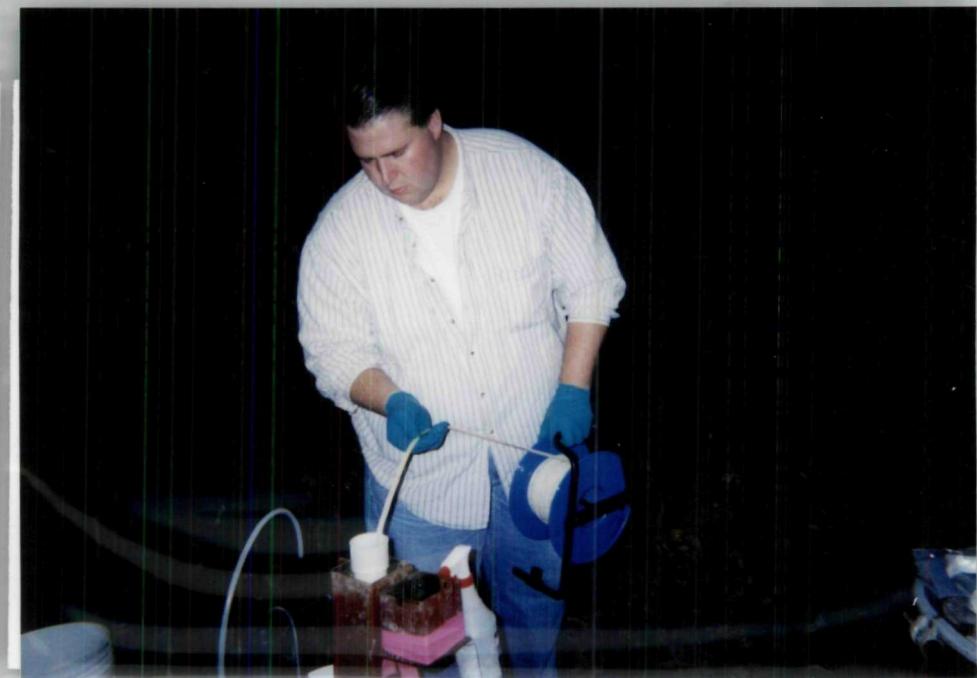
Site: American Chemical Services, Inc.
Proj. #: 46517/46518
Roll: 1 Photo #: 7
Date: 10-13-99 Time: 09:20
Photographer: Chad Gailey
Description: Photo facing northwest at PZ8 of
Rudy Stein taking initial
measurement for draw down.

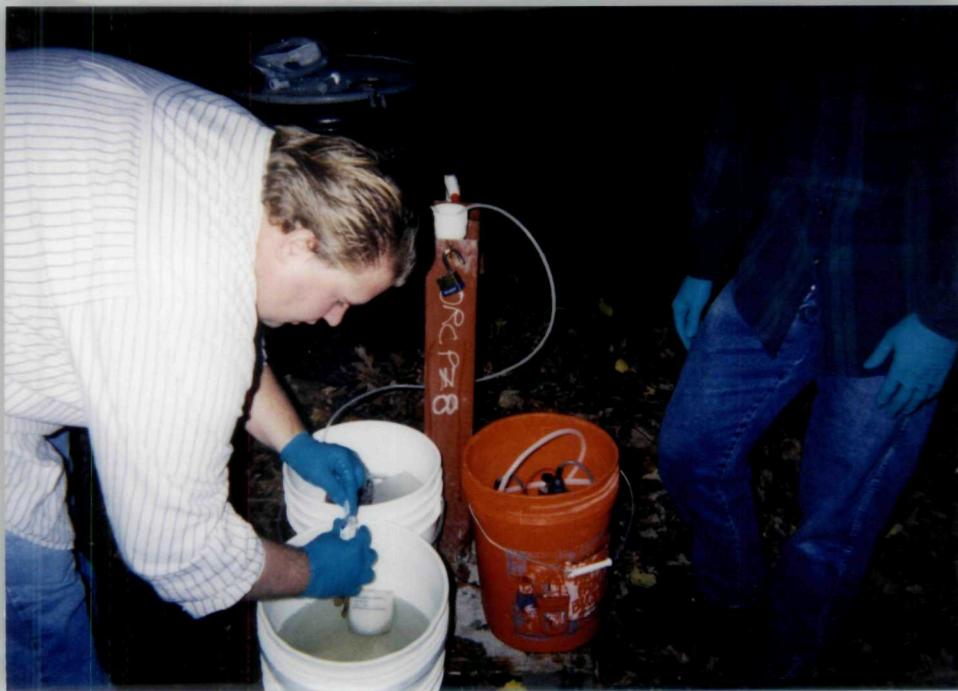
Site: American Chemical Services, Inc.
Proj. #: 46517/46518
Roll: 1 Photo #: 8
Date: 10-13-99 Time: 09:47
Photographer: Chad Gailey
Description: Photo facing east at PZ8 of Rudy
filling a VOA bottle for ORC
sampling

- 09:25 STARTED Piling well @ PZ8
Rudy Stein Cheeky Draw Drift
862 Looks good no apparent
Draw Down
- 09:45 START Sampling, Parameter, #1, Tappide
Rudy, Cane, ARE STABLE,
Picture #8 Facing East @ PZ8
of Rudy Log @ a VOA bottom.
Rudy is Decaying Piling while
Chas Smith is taking Goniometer
measurement @ PZ8
- 10:05 STARTED Piling @ PZ5
- 10:25 Start Sampling @ PZ5
- 10:30 Picture #9 Facing South East @
PZ5 of Rudy Stein filling
a VOA Cuttie
- 10:40 Rudy Stein Decaying Piling mob
to PZ6, Chas Smith is
taking no other levels of surface
wells
- 10:45 Picture #10 Facing North @ PZ6
of Rudy Stein Take Goniometer
Elevation. To 71.
- 10:50 START Piling @ PZ6

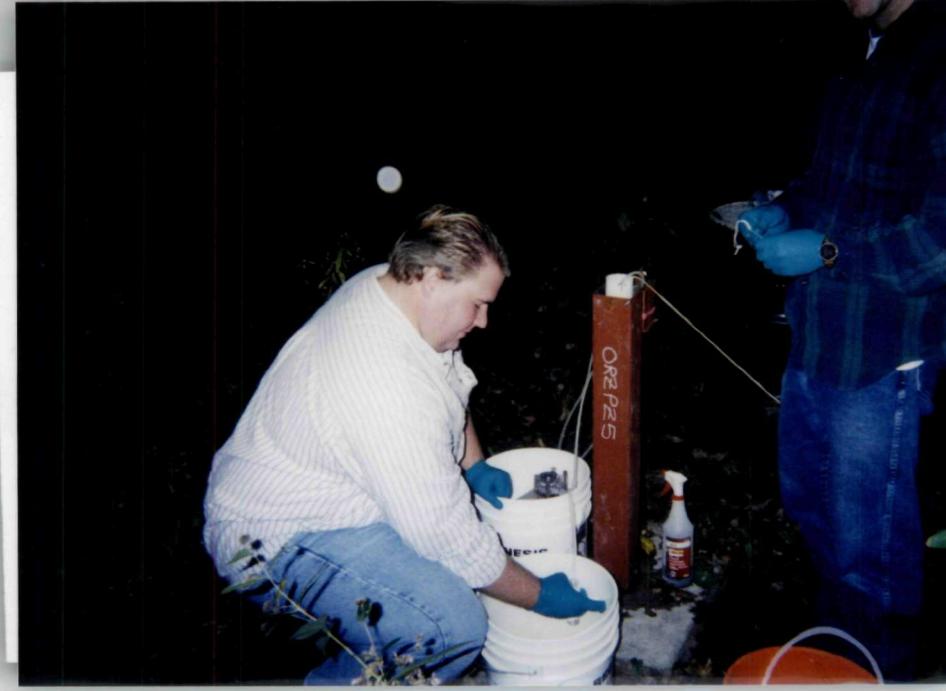
Site: American Chemical Services, Inc.
Proj. #: 46517/46518
Roll: 1 Photo #: 9
Date: 10-13-99 Time: 10:30
Photographer: Chad Gailey
Description: Photo facing southeast at PZ5 of
Rudy Stein filling a VOA bottle
for ORC sampling.

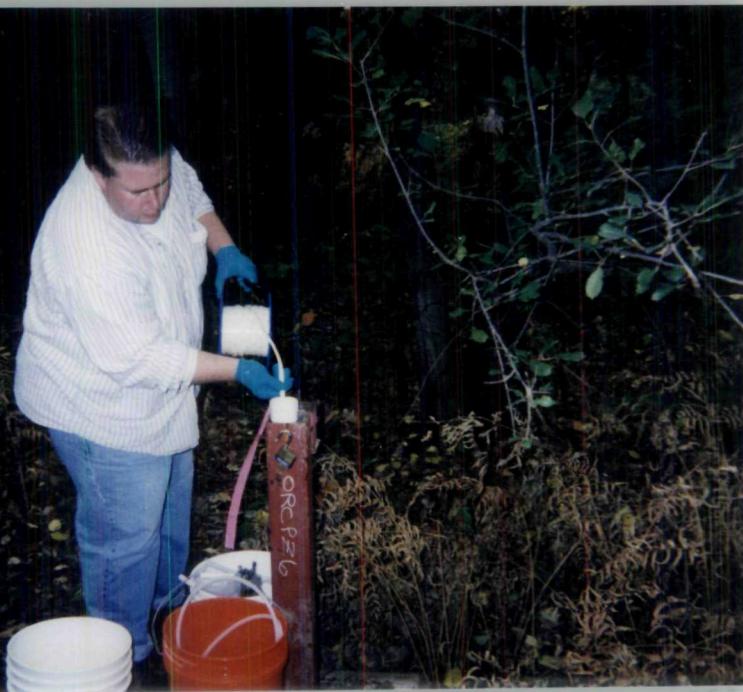
Site: American Chemical Services, Inc.
Proj. #: 46517/46518
Roll: 1 Photo #: 10
Date: 10-13-99 Time: 10:45
Photographer: Chad Gailey
Description: Photo facing north at PZ6 of
Rudy Stein taking initial
groundwater elevation for draw
down.

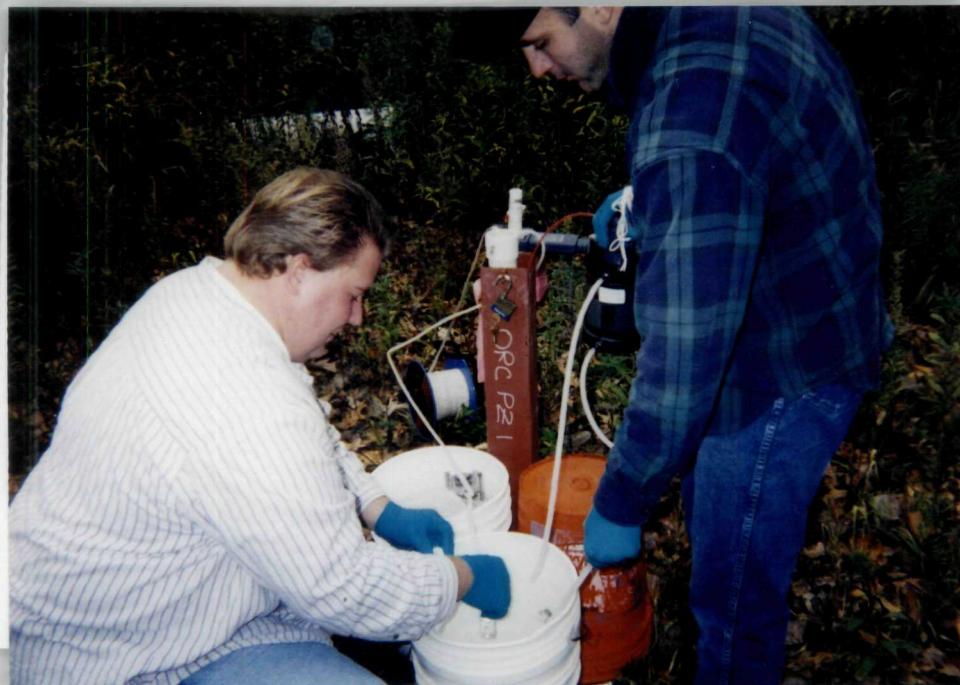
Site: American Chemical Services, Inc.
Proj. #: 46517/46518
Roll: 1 Photo #: 12
Date: 10-13-99 Time: 13:45
Photographer: Chad Gailey
Description: Photo facing north at PZ1 of
Rudy Stein filling a VOA for
ORC sampling.

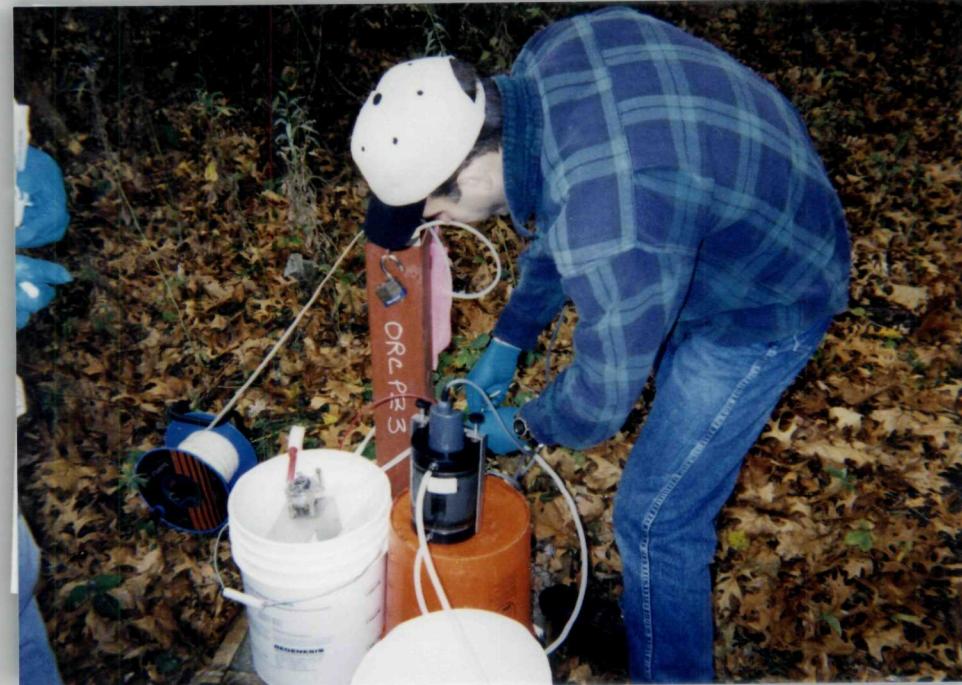
Site: American Chemical Services, Inc.
Proj. #: 46517/46518
Roll: 1 Photo #: 13
Date: 10-13-99 Time: 14:12
Photographer: Chad Gailey
Description: Photo facing east at PZ3 of Chad
Smith disconnecting the Horiba
water quality meter.

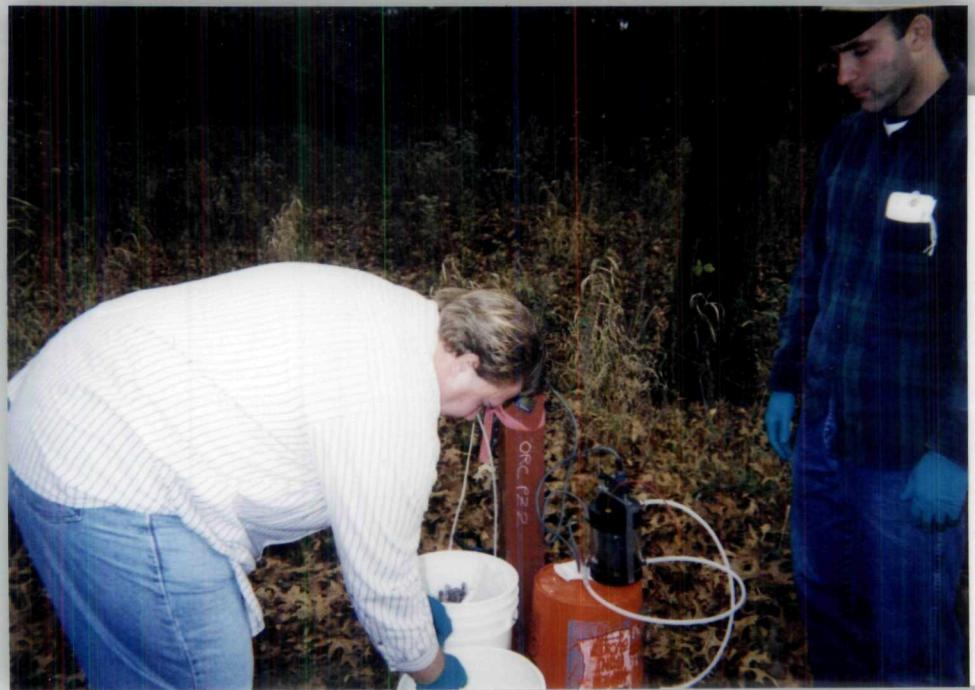
Site: American Chemical Services, Inc.
Proj. #: 46517/46518
Roll: 1 Photo #:14
Date: 10-13-99 Time: 15:37
Photographer: Chad Gailey
Description: Photo facing east at PZ2 of Rudy Stein filling a VOA for ORC sampling.

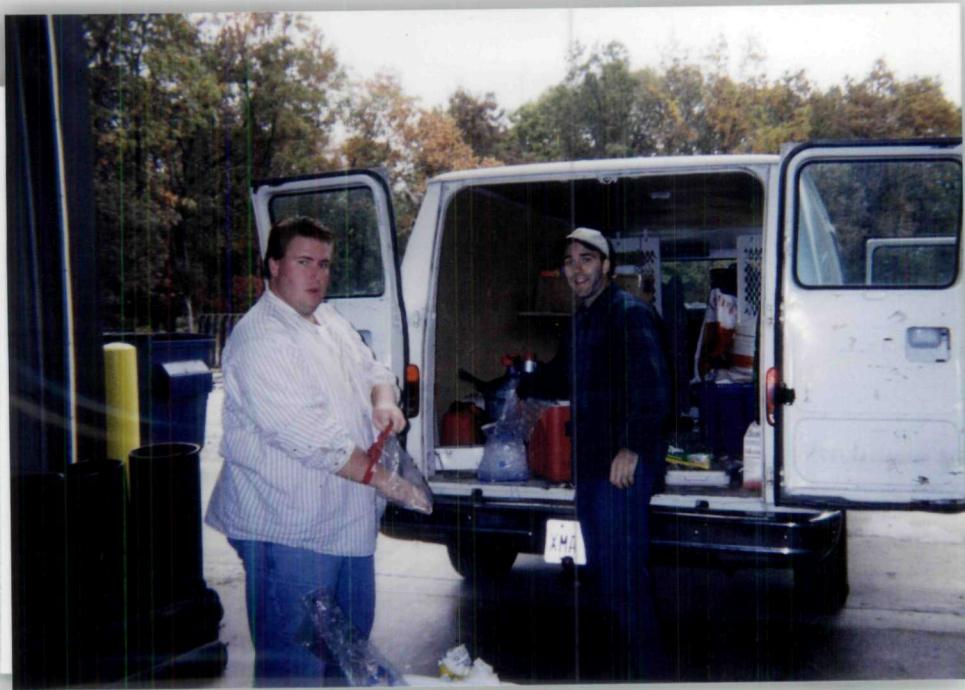
Site: American Chemical Services, Inc.
Proj. #: 46517/46518
Roll: 1 Photo #:15
Date: 10-13-99 Time: 16:30
Photographer: Chad Gailey
Description: Photo facing southwest of Chad Smith and Rudy Stein packing ORC samples in coolers.

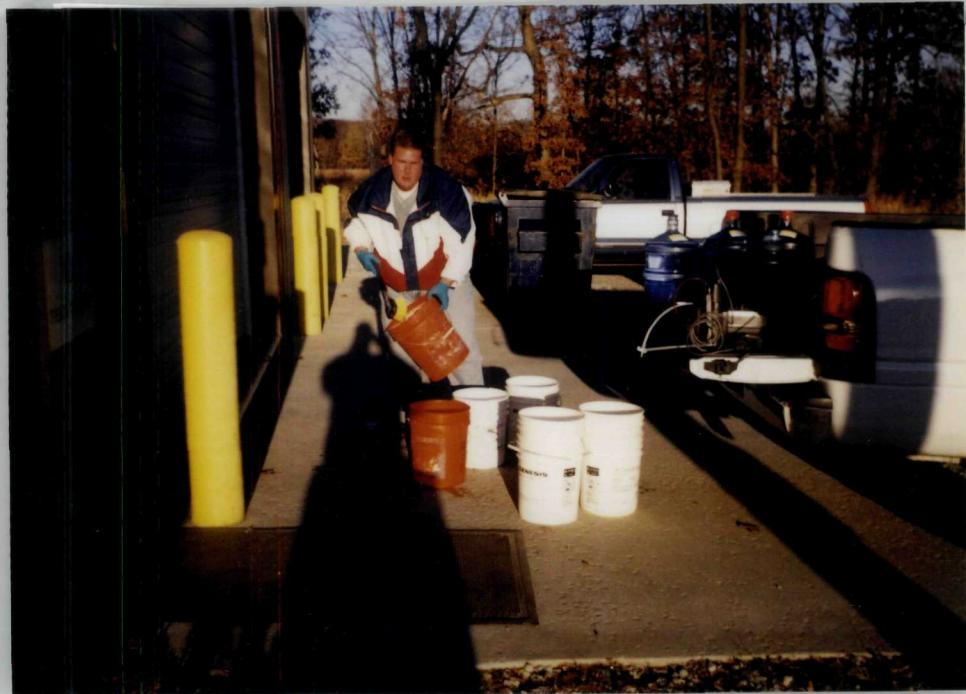
Site: American Chemical Services, Inc.
Proj. #: 46517/46518
Roll: 1 Photo #: 7
Date: 11-04-99 Time: 07:45
Photographer: Chad Gailey
Description: Photo facing west at the water treatment Bld. of Rudy Stein deconning equipment for ORC sampling.

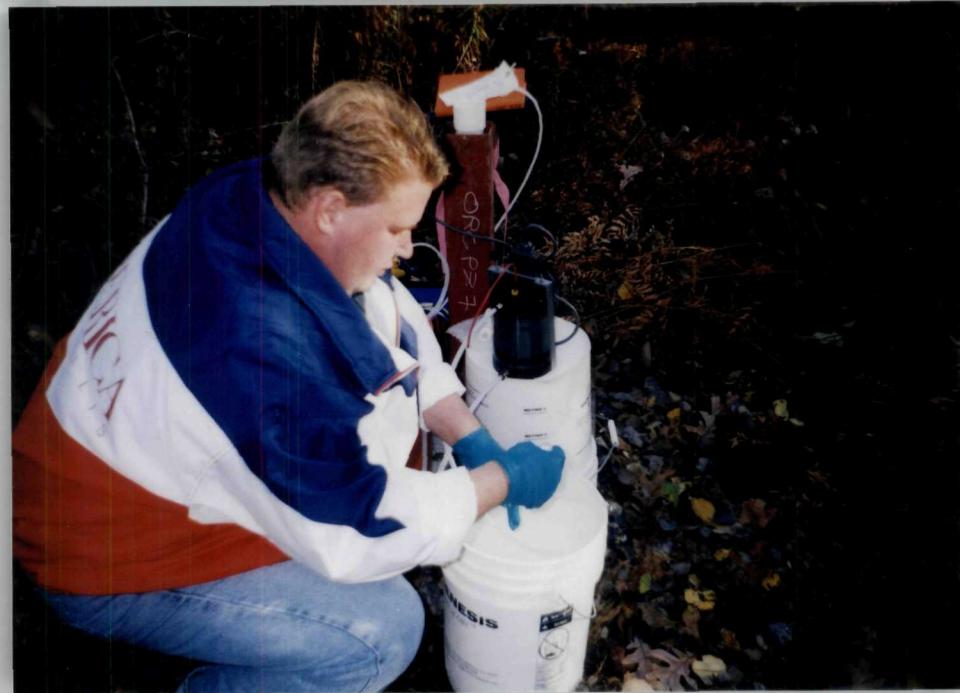
Site: American Chemical Services, Inc.
Proj. #: 46517/46518
Roll: 1 Photo #: 8
Date: 11-04-99 Time: 08:45
Photographer: Chad Gailey
Description: Photo facing north of Rudy Stein filling a VOA at PZ7 for ORC sampling.

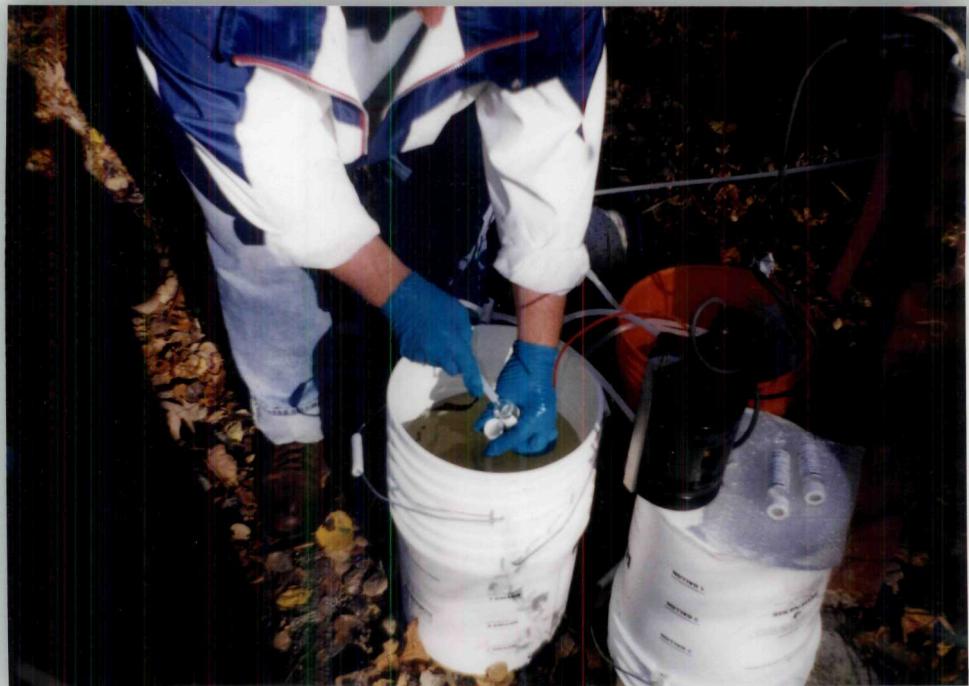
Site: American Chemical Services, Inc.
Proj. #: 46517/46518
Roll: 1 Photo #:9
Date: 11-04-99 Time: 09:30
Photographer: Chad Gailey
Description: Photo facing north at PZ6 of Rudy filling a Voa for ORC sampling.

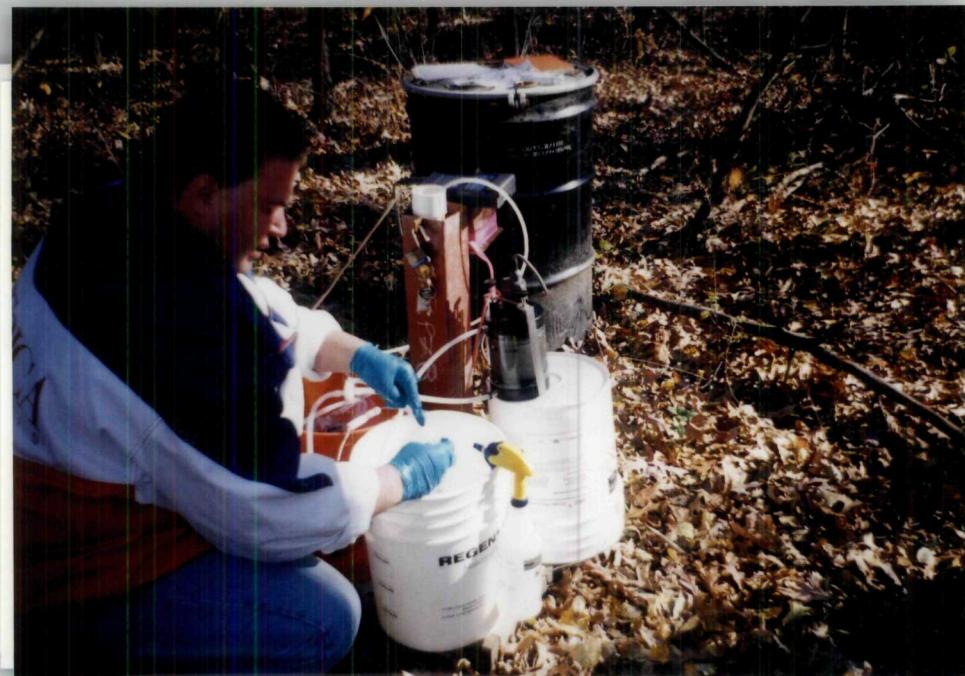
Site: American Chemical Services, Inc.
Proj. #: 46517/46518
Roll: 1 Photo #:10
Date: 11-04-99 Time: 10:05
Photographer: Chad Gailey
Description: Photo facing east at PZ8 of rudy filling a VOA for ORC sampling.

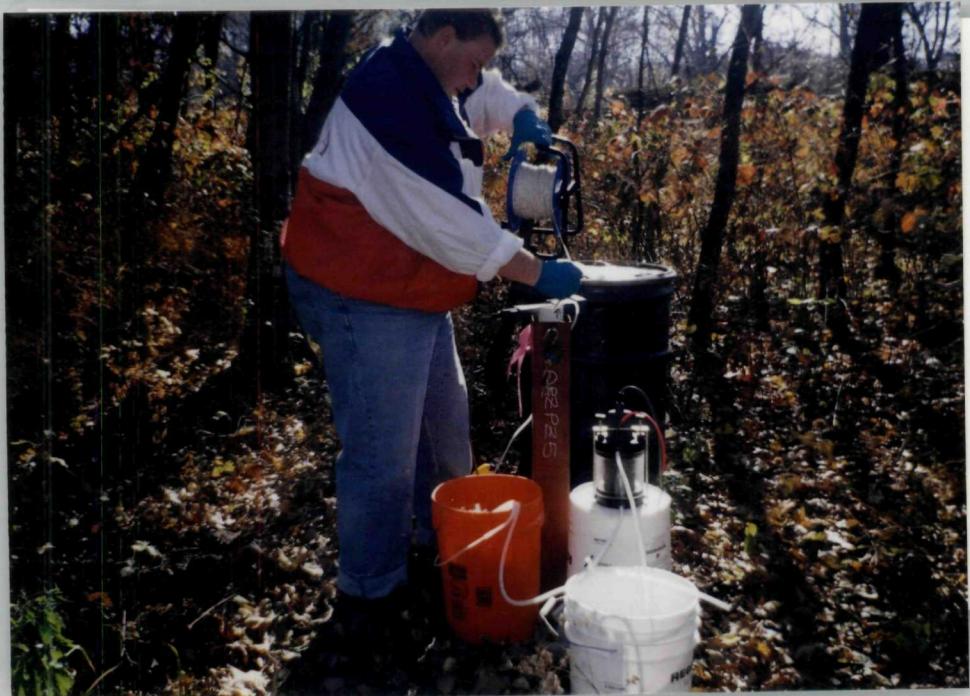
Site: American Chemical Services, Inc.
Proj. #: 46517/46518
Roll: 1 Photo #:11
Date: 11-04-99 Time: 10:20
Photographer: Chad Gailey
Description: Photo facing south at PZ5 of
Rudy Stein checking draw down.

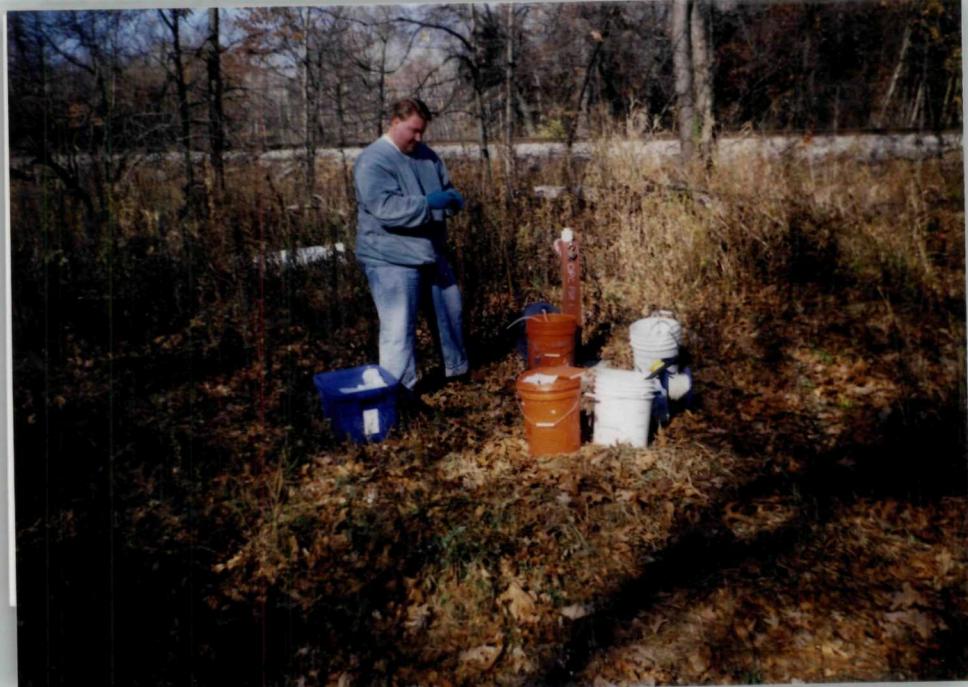
Site: American Chemical Services, Inc.
Proj. #: 46517/46518
Roll: 1 Photo #:12
Date: 11-04-99 Time: 12:15
Photographer: Chad Gailey
Description: Photo facing north at PZ1 of
Rudy Stein pulling field blank.

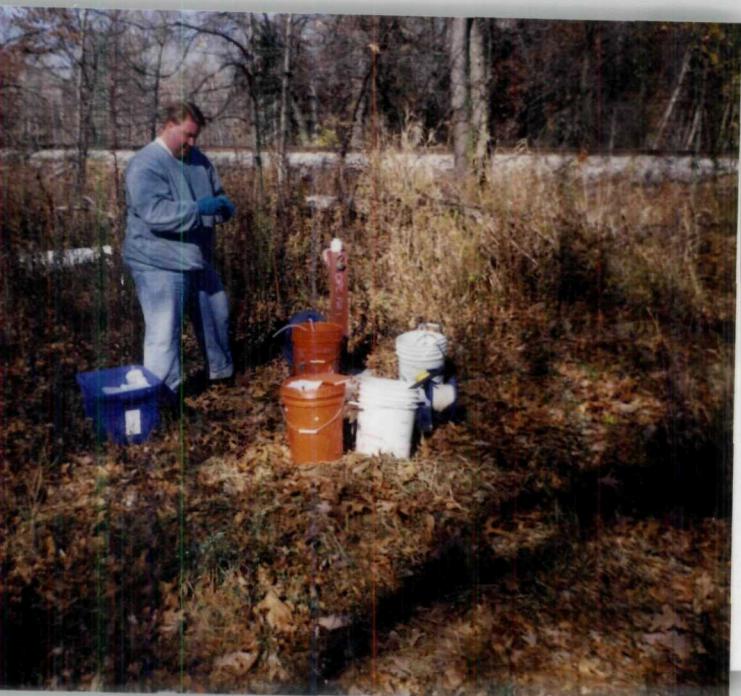
Site: American Chemical Services, Inc.
Proj. #: 46517/46518
Roll: 1 Photo #:13
Date: 11-04-99 Time: 13:00
Photographer: Chad Gailey
Description: Photo facing north at PZ1 of
Rudy Stein fill a VOA for ORC
sampling.

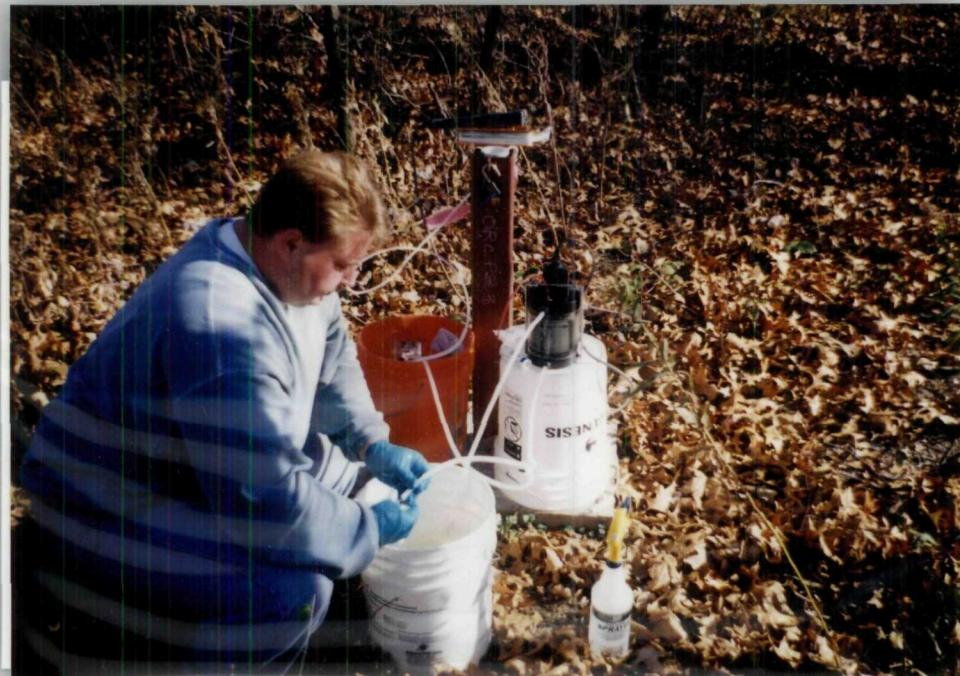
Site: American Chemical Services, Inc.
Proj. #: 46517/46518
Roll: 1 Photo #:14
Date: 11-04-99 Time: 13:32
Photographer: Chad Gailey
Description: Photo facing east at PZ3 of Rudy
filling a VOA for ORC sampling.
